An Investigation of Stream Channel Modifications at Unauthorized Suction Dredging Sites on the South Fork Clearwater River, October 7 and 8, 2015

Dan Kenney
North Zone Fisheries Biologist
Nez Perce-Clearwater National Forests
February 3, 2016

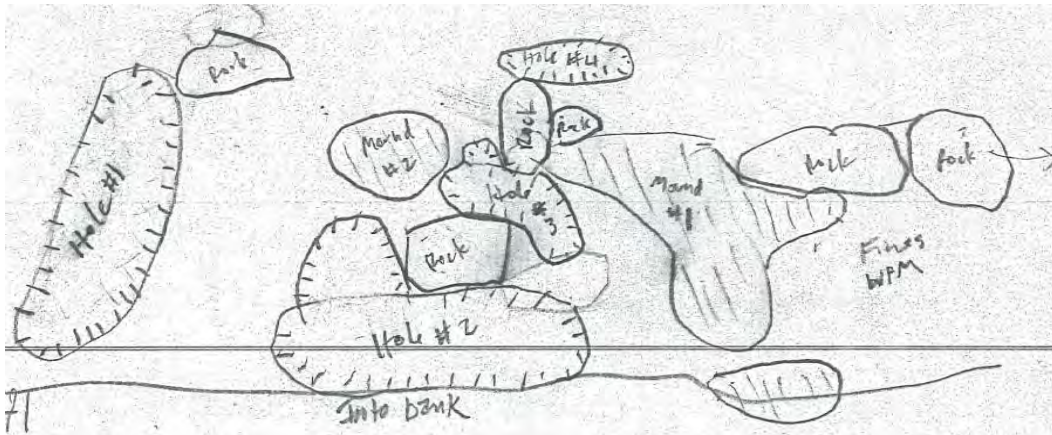
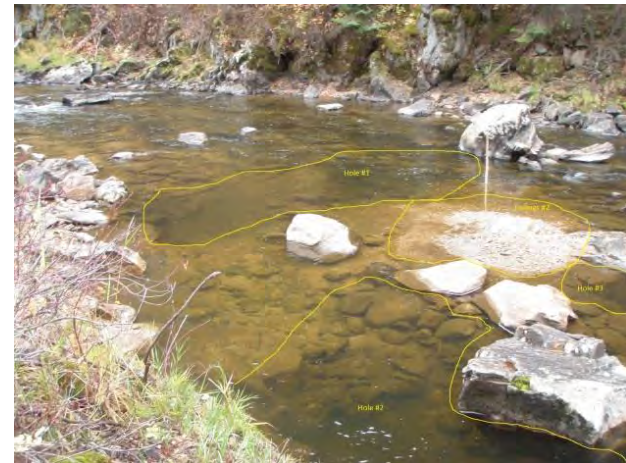
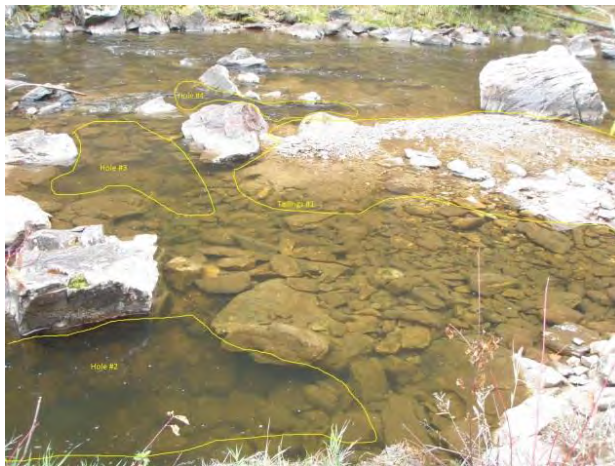
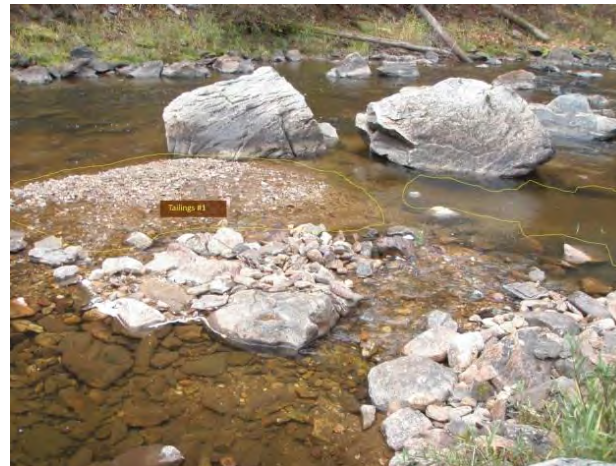
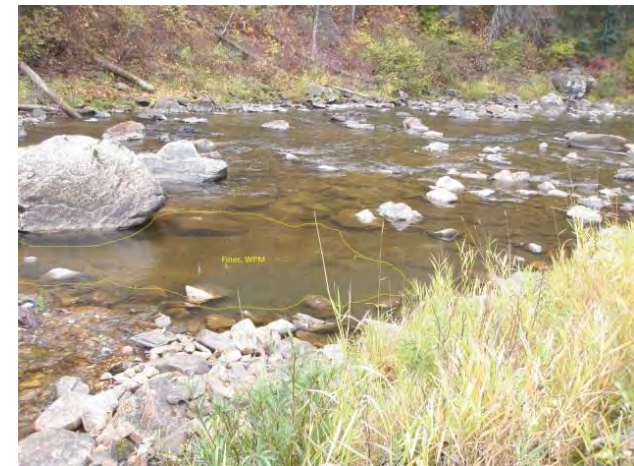
SFCR Unauthorized Site #1, October 7, 2015

Upper feature location	Hughes Site?	Dredge Fines?	WPM?	Notes:
UTM 11 610279E, 5076040N	3	Yes	Yes	~10 ft of bank alteration just below Moose Ck confluence

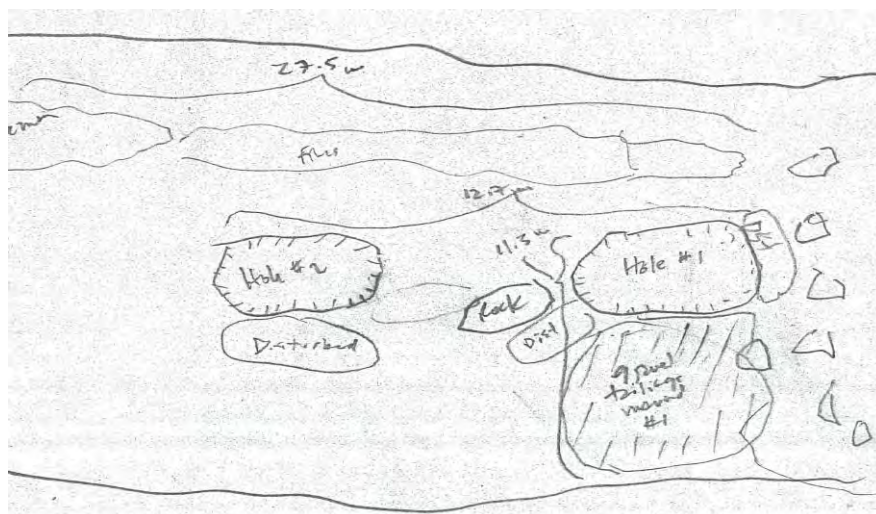
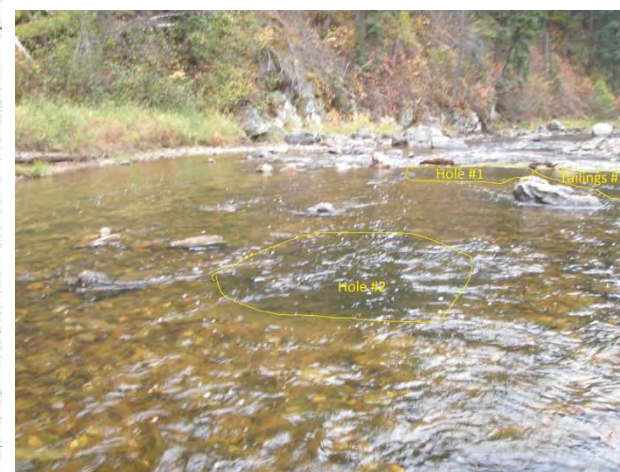
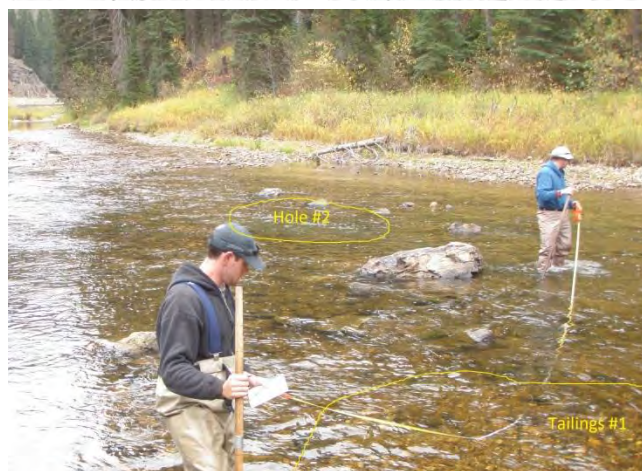
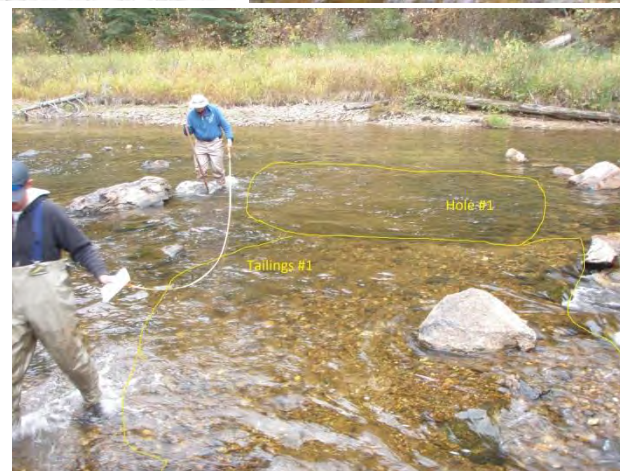
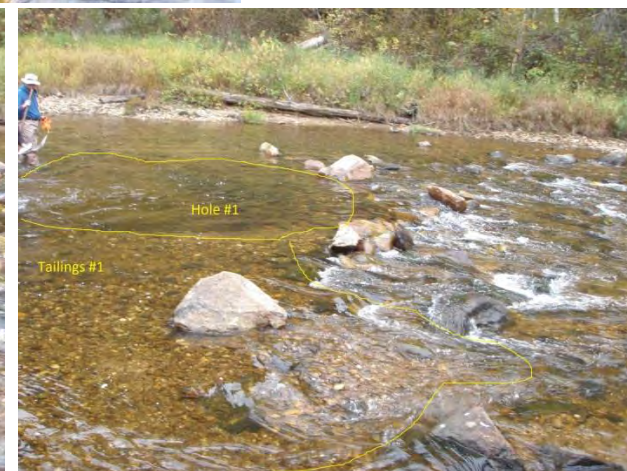
SFCR Unauthorized Site #2, October 7, 2015

Upper feature location	Hughes Site?	Dredge Fines?	WPM?	Notes:				
UTM 11 610333E, 5076053N	3	Yes	Yes	n/a

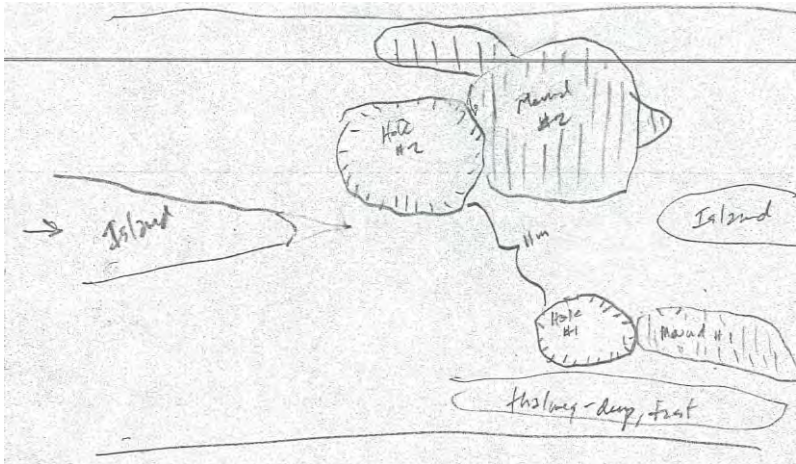
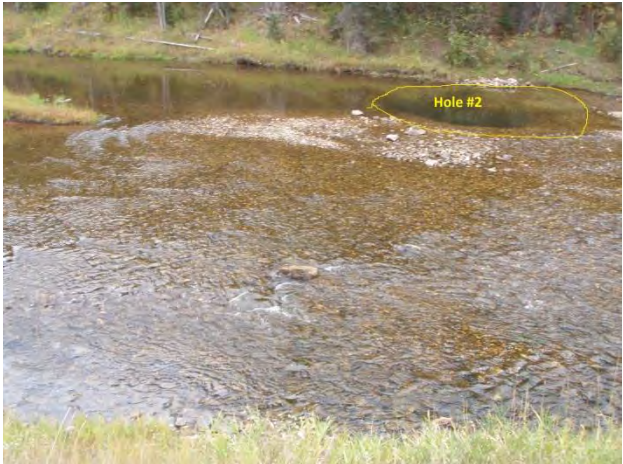
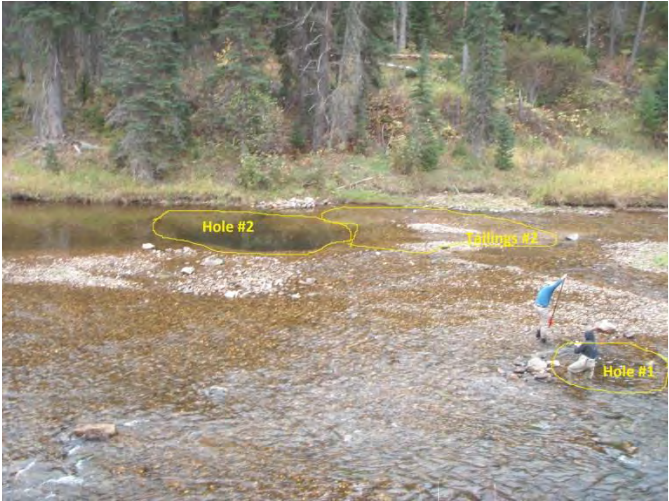
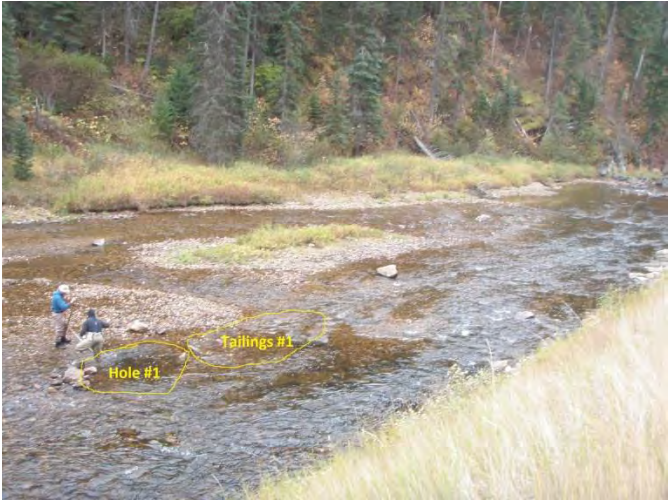
SFCR Unauthorized Site #3, October 7, 2015

Upper feature location	Hughes Site?	Dredge Fines?	WPM?	Notes:					
UTM 11 610398E, 5076074N	4	Yes	No	n/a

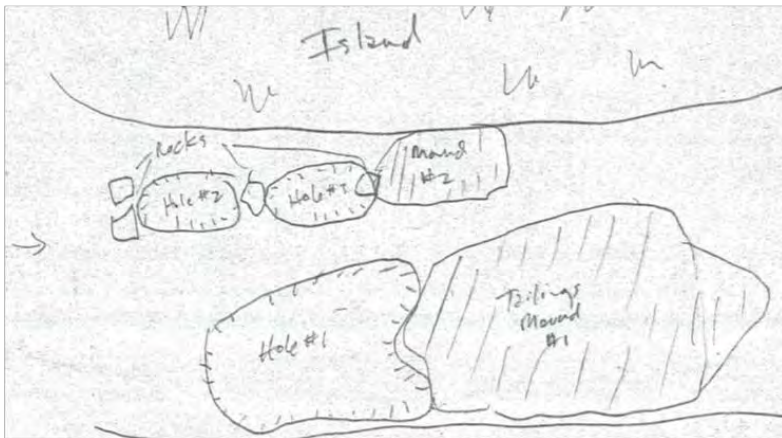
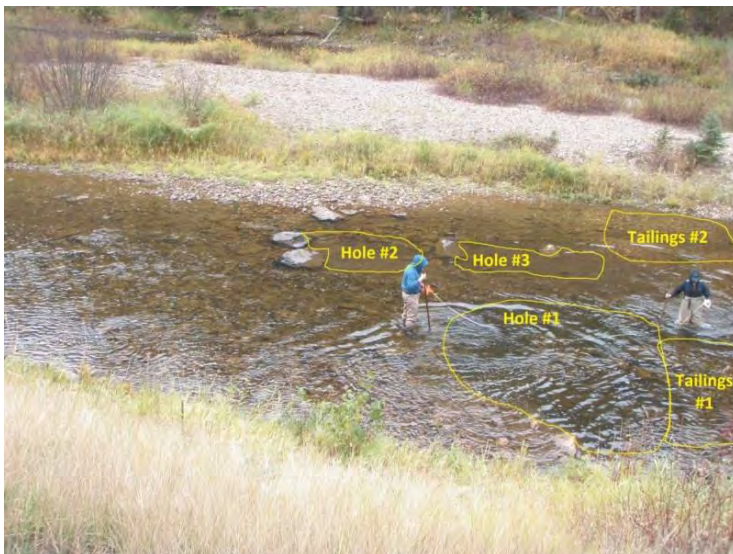
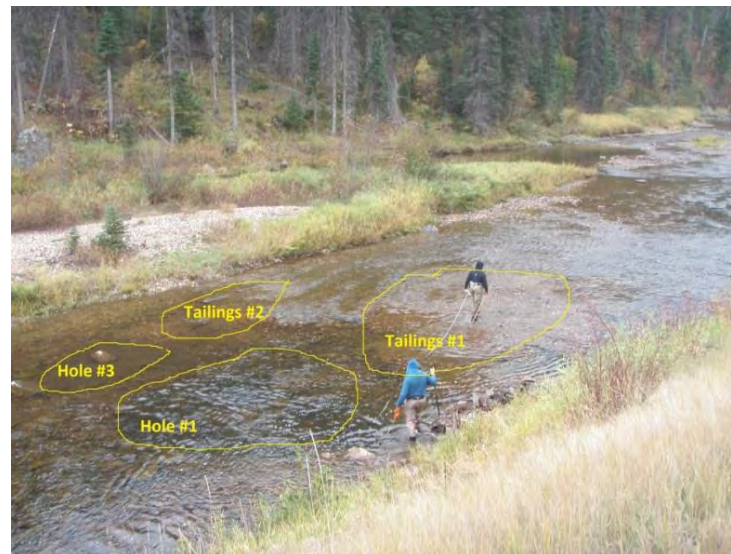
SFCR Unauthorized Site #4, October 7, 2015

Upper feature location	Hughes Site?	Dredge Fines?	WPM?	Notes:				
UTM 11 610459E, 5076104N	4	Yes	No	n/a

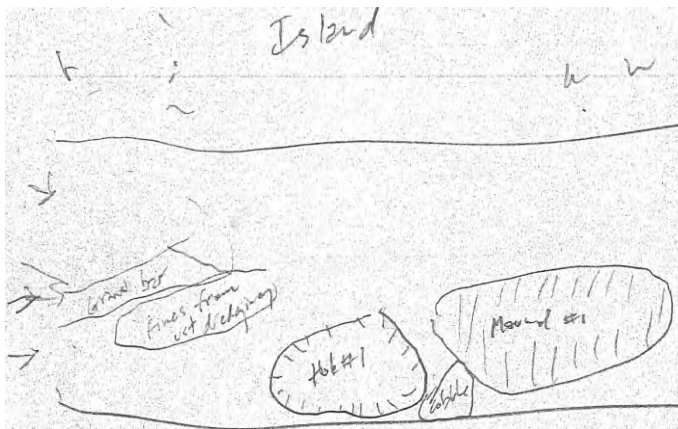
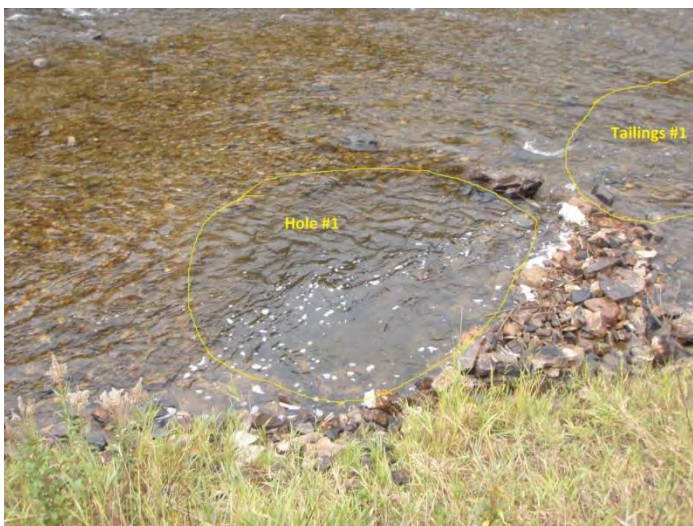
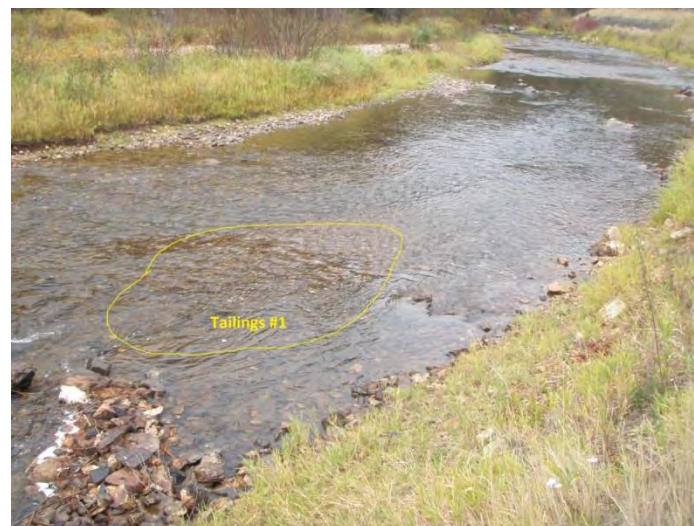
SFCR Unauthorized Site #5, October 7, 2015

Upper feature location	Hughes Site?	Dredge Fines?	WPM?	Notes:
n/a	4	Yes	No	n/a

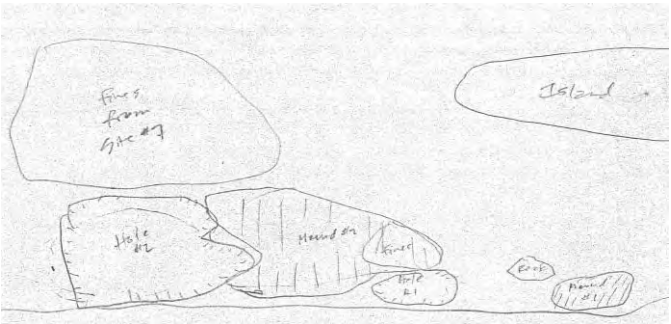
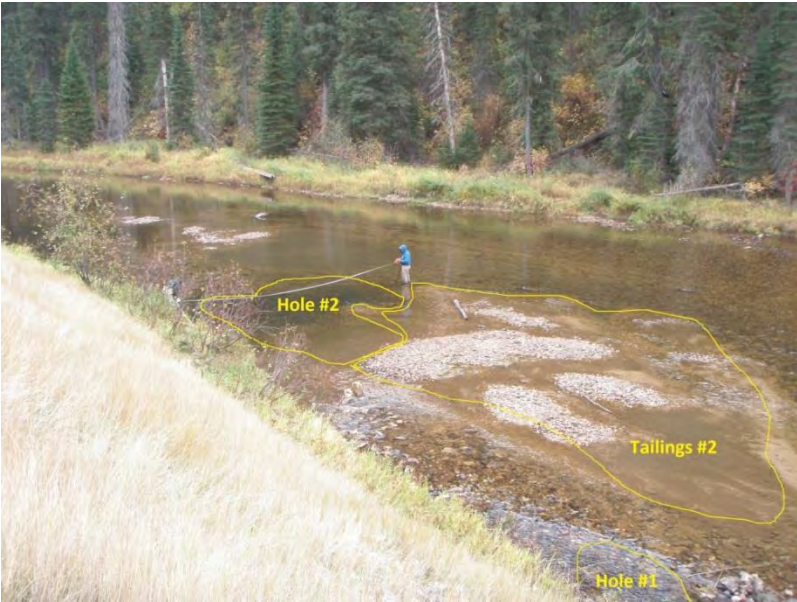
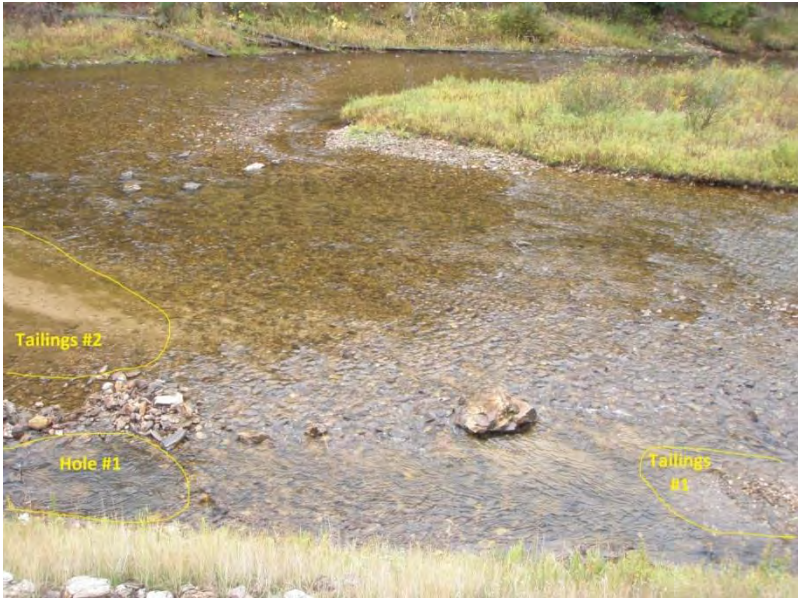
SFCR Unauthorized Site #6, October 7, 2015

Upper feature location	Hughes Site?	Dredge Fines?	WPM?	Notes:
UTM 11 610548E, 5076093N	5	Yes	No	Fines accumulations up to about 4" in depth

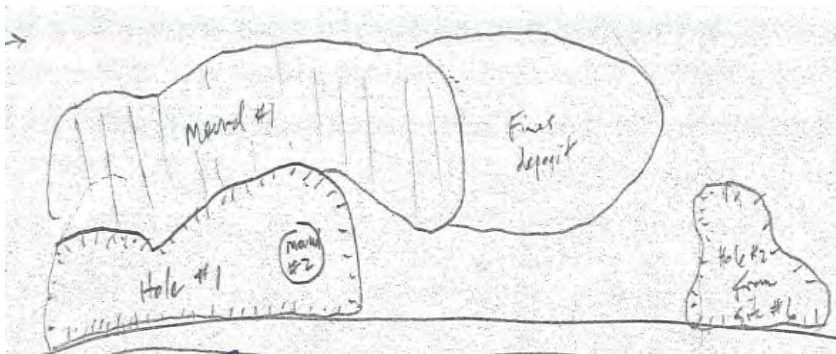
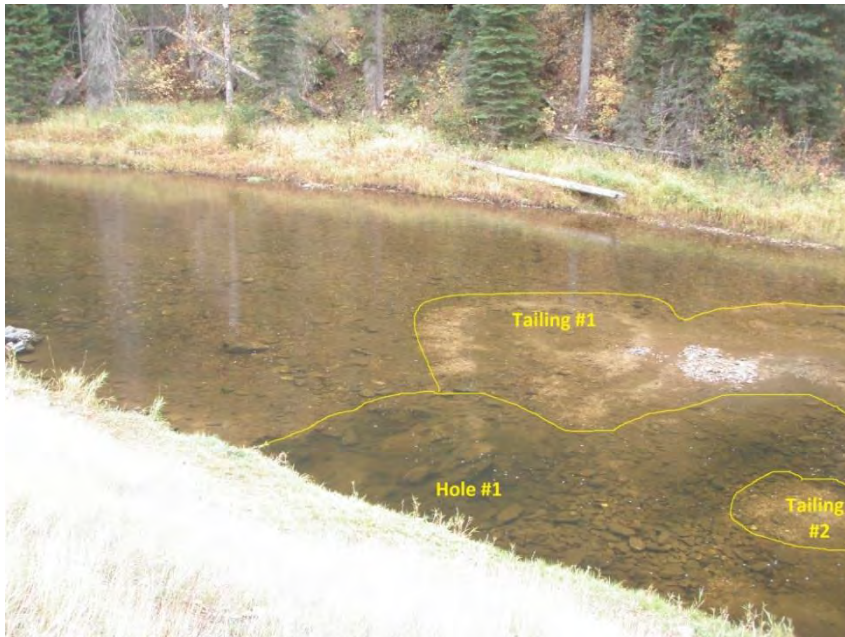
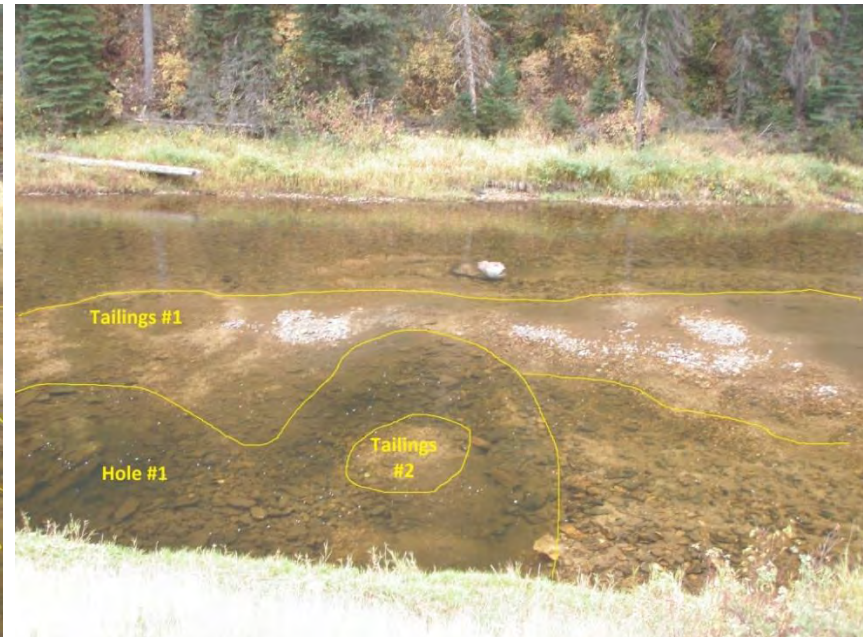
SFCR Unauthorized Site #7, October 7, 2015

Upper feature location	Hughes Site?	Dredge Fines?	WPM?	Notes:
UTM 11 610574E, 5076090N	5	Yes	Yes	Bank undercut for most of length of Hole #1, fines up to 2"

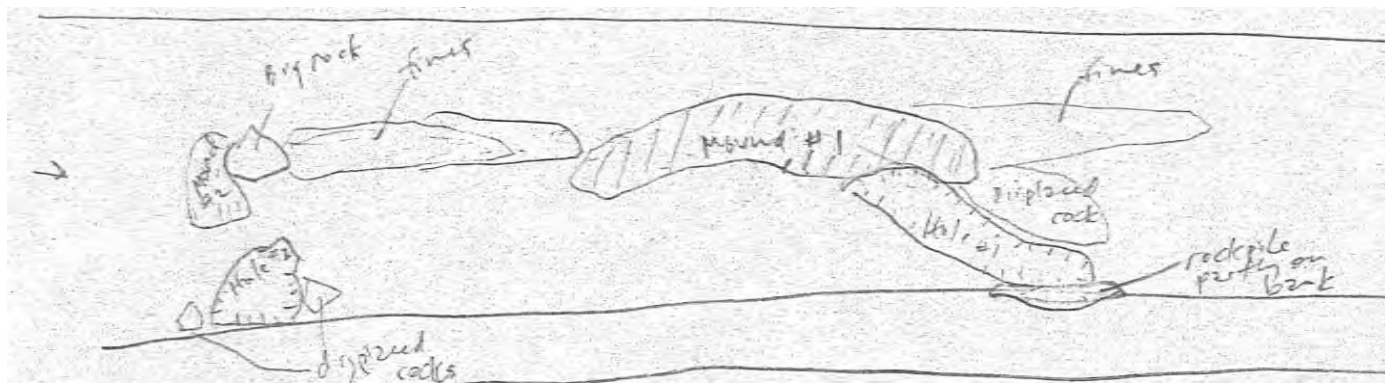
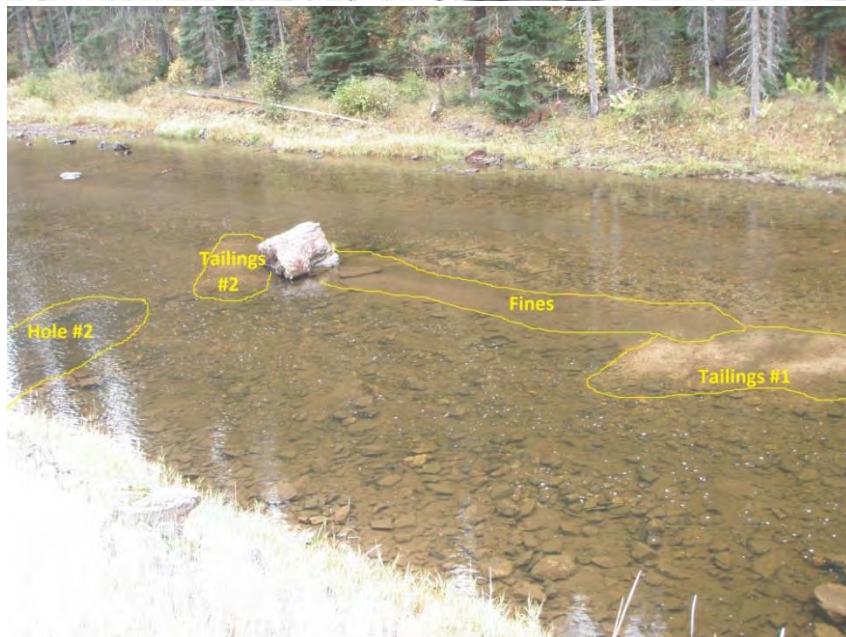
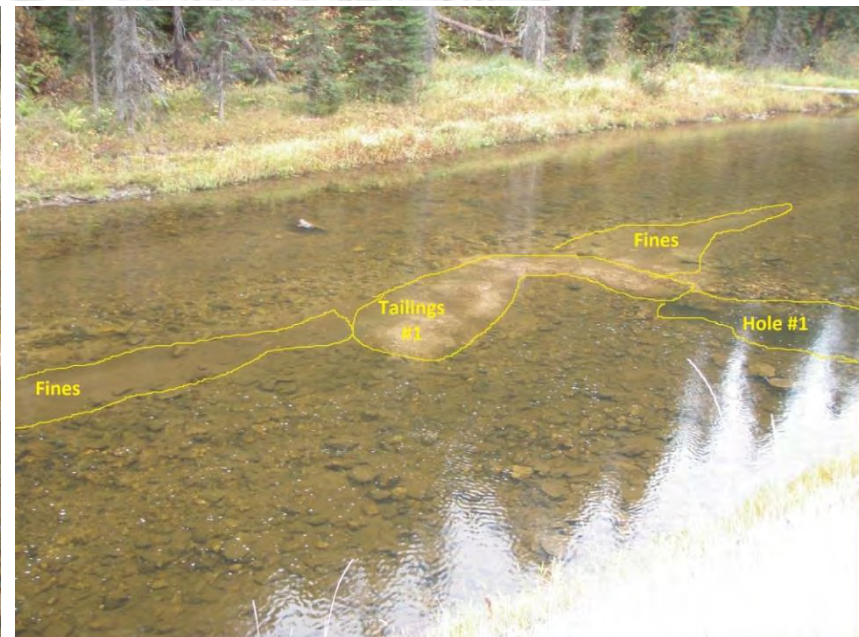
SFCR Unauthorized Site #8, October 7, 2015

Upper feature location	Hughes Site?	Dredge Fines?	WPM?	Notes:					
UTM 11 610645E, 5076084N	5	Yes	No	n/a

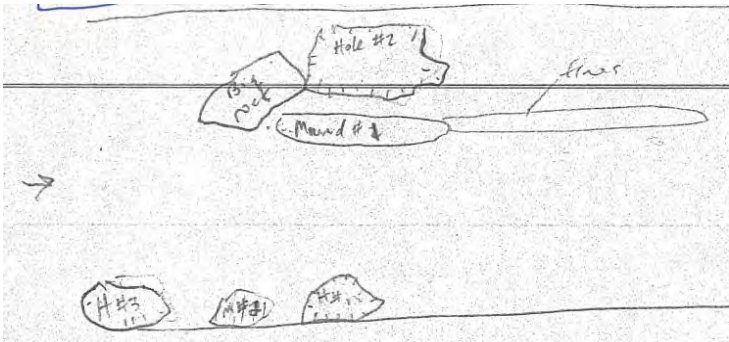
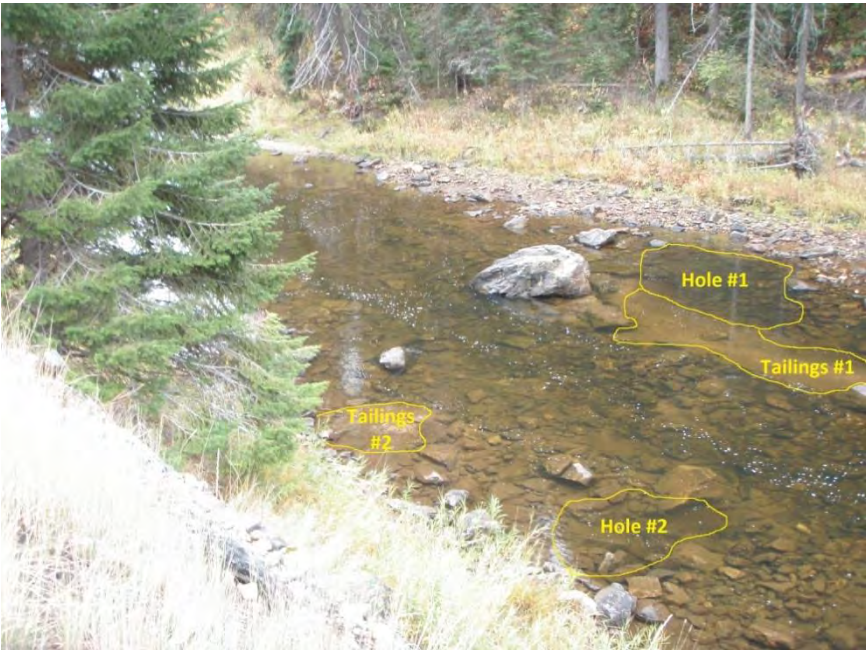
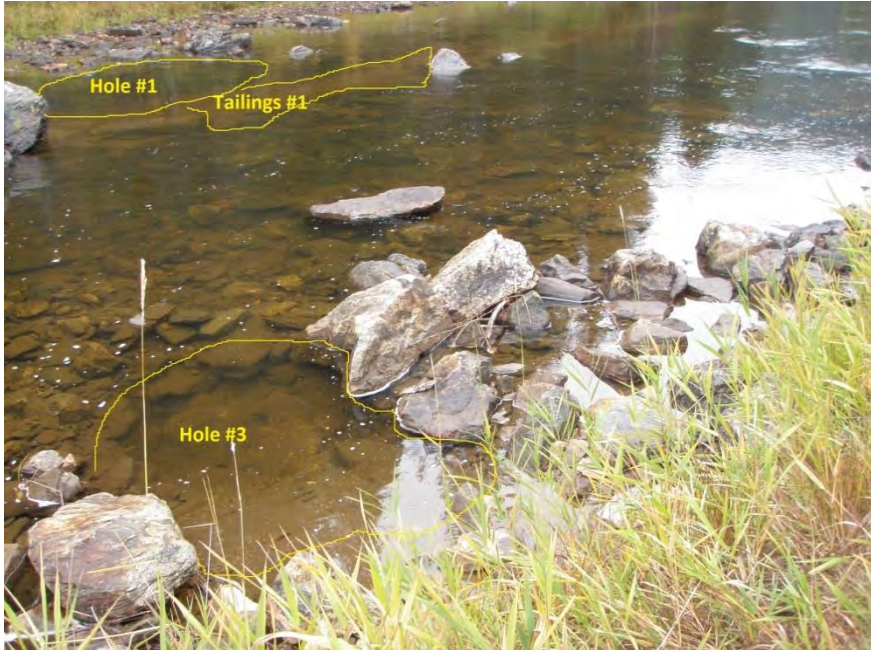
Upper feature location	Hughes Site?	Dredge Fines?	WPM?	Notes:					
UTM 11 610700E, 5076075N	6	Yes	Yes	n/a

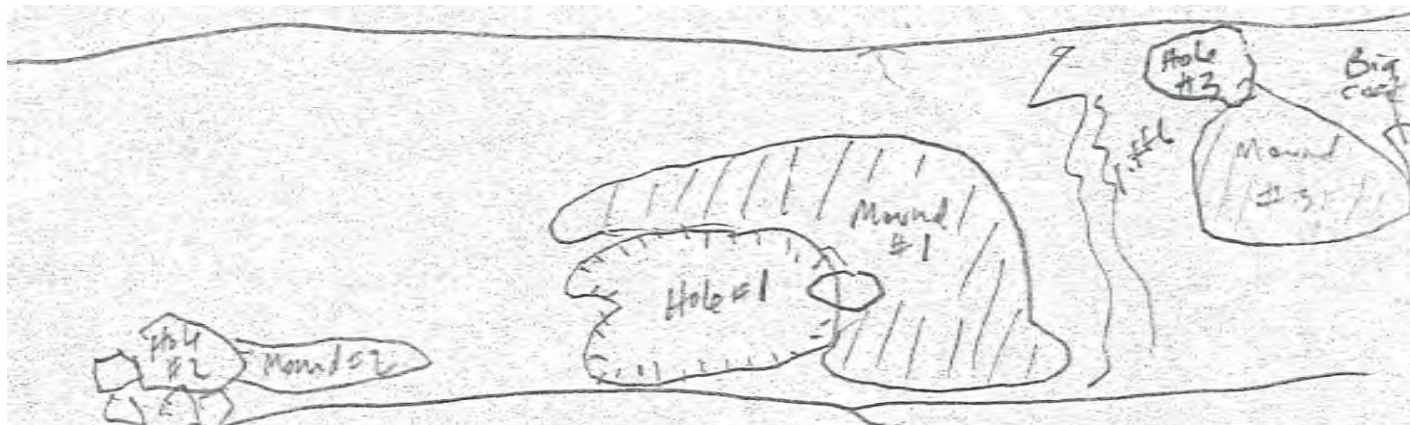
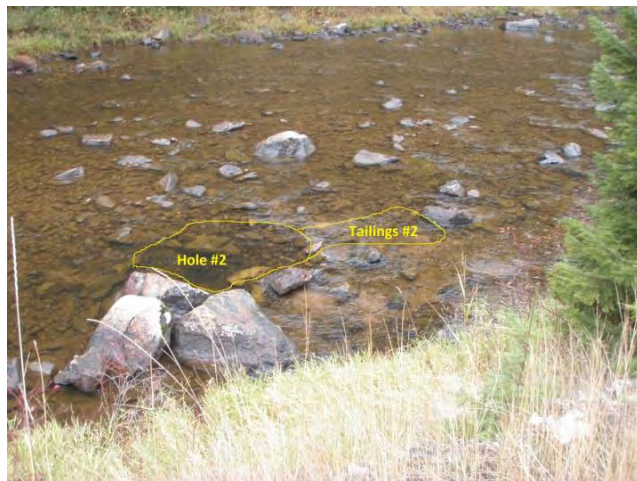
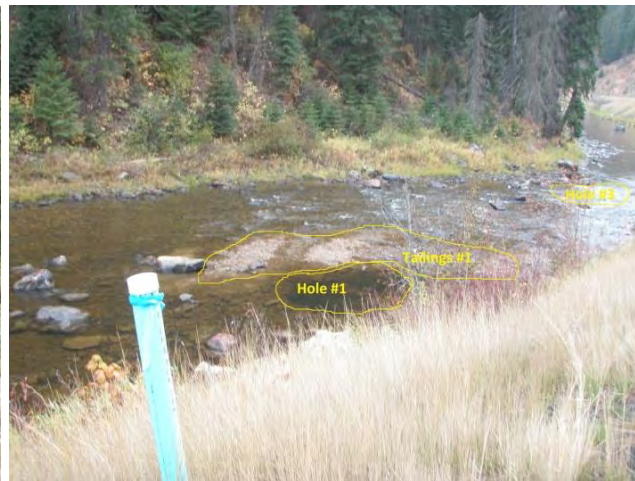
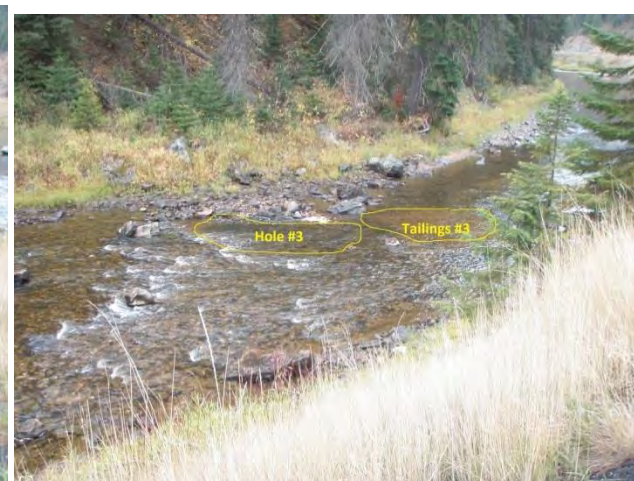
SFCR Unauthorized Site #10, October 7, 2015

Upper feature location	Hughes Site?	Dredge Fines?	WPM?	Notes:
UTM 11 610739E, 5076048N	6	Yes	Yes	n/a

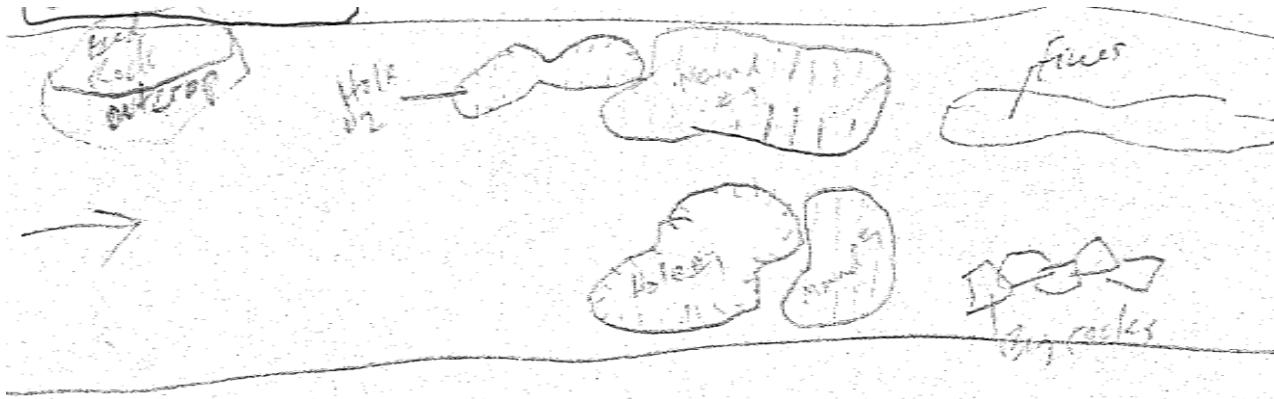
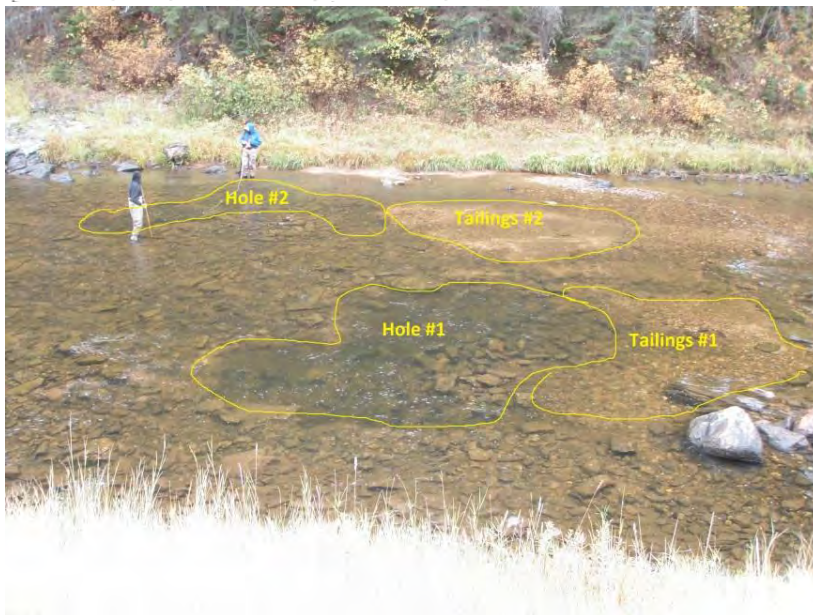
SFCR Unauthorized Site #11, October 7, 2015

Upper feature location	Hughes Site?	Dredge Fines?	WPM?	Notes:
UTM 11 610918E, 5075883N	n/a	Yes	Yes	Fines accumulations up to about 6" in depth

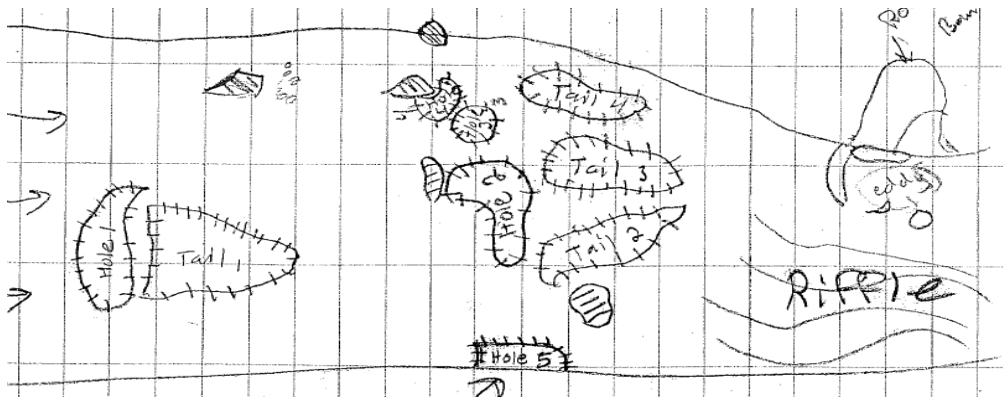
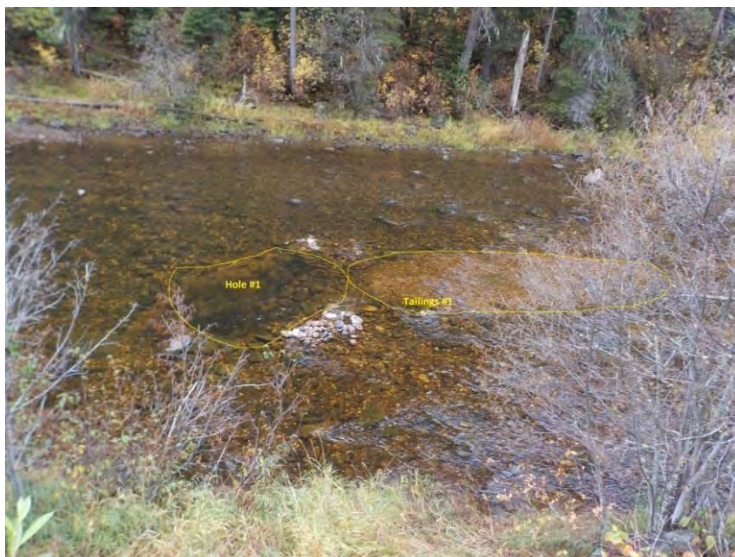
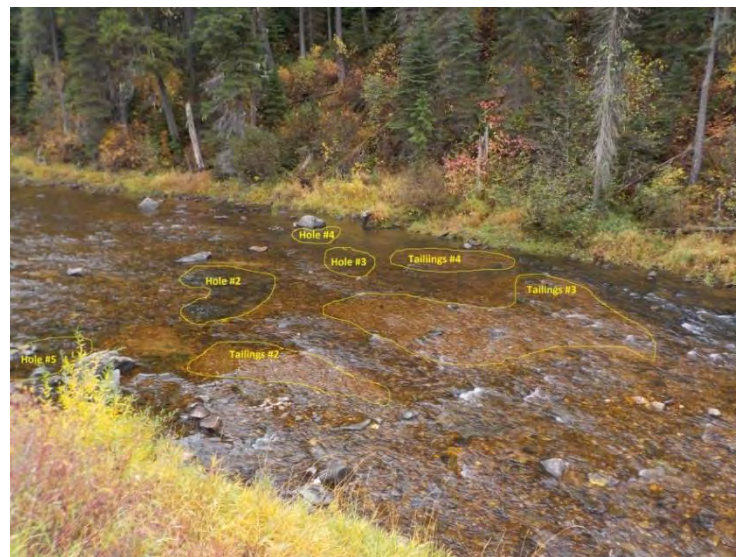
SFCR Unauthorized Site #12, October 8, 2015

Upper feature location	Hughes Site?	Dredge Fines?	WPM?	Notes:
UTM 11 614062E, 5075540N	8	No	No	Bank undercut for portion of length of Hole #5

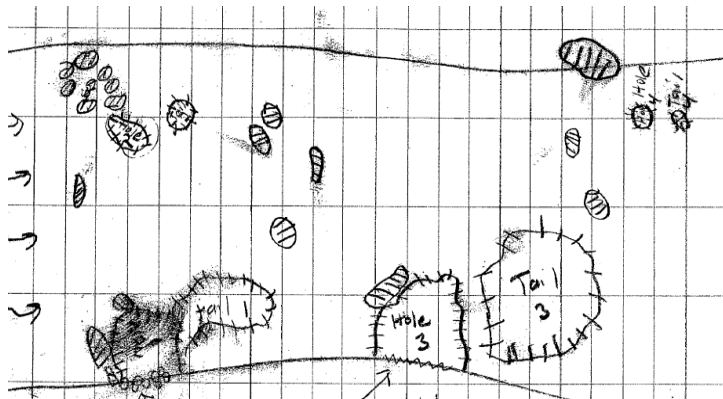
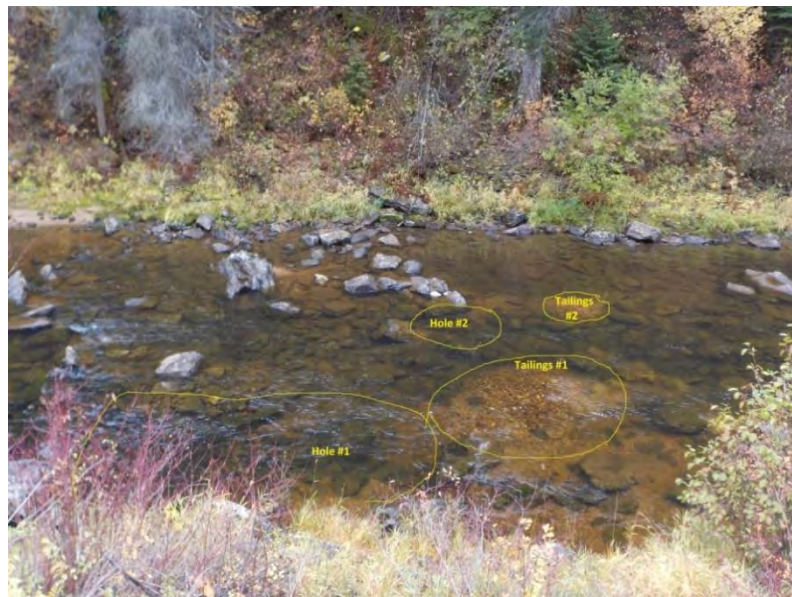
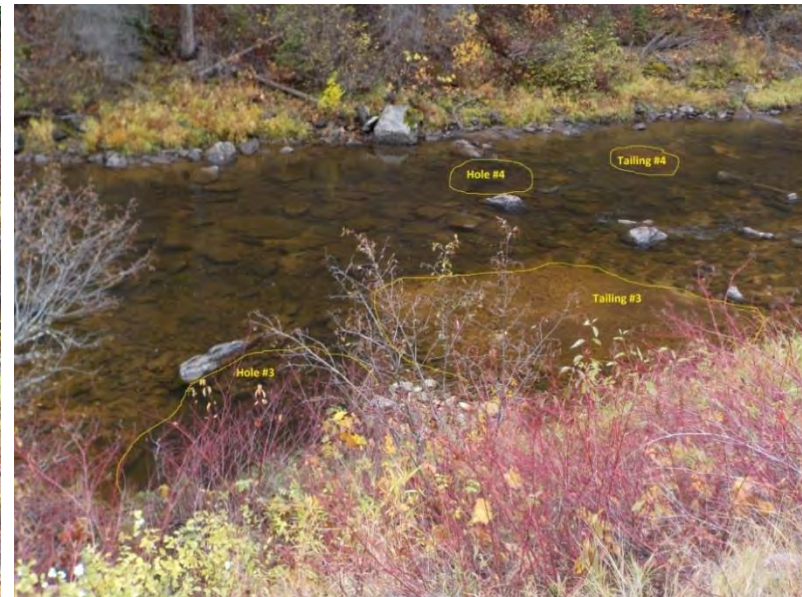
SFCR Unauthorized Site #13, October 8, 2015

Upper feature location	Hughes Site?	Dredge Fines?	WPM?	Notes:				
UTM 11 613792E, 5075546N	7	No	Yes	n/a

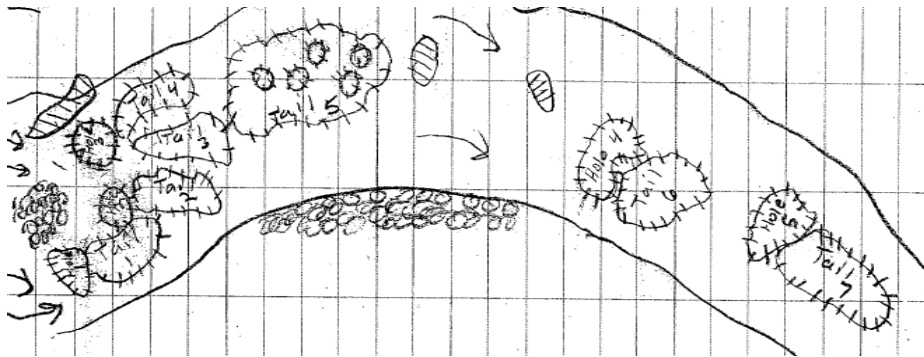
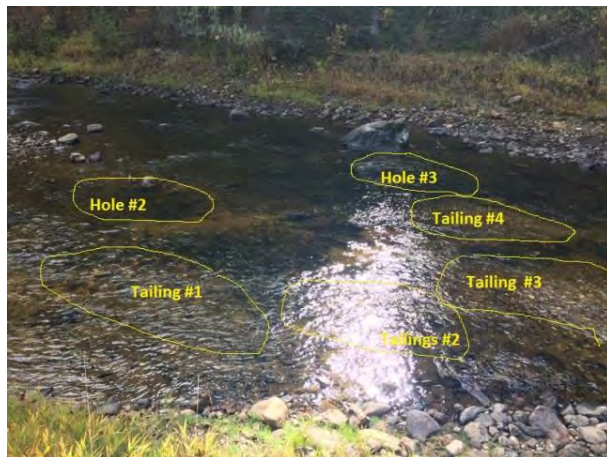
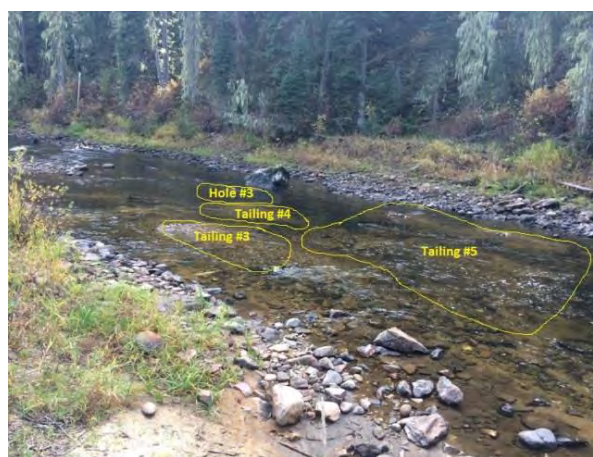
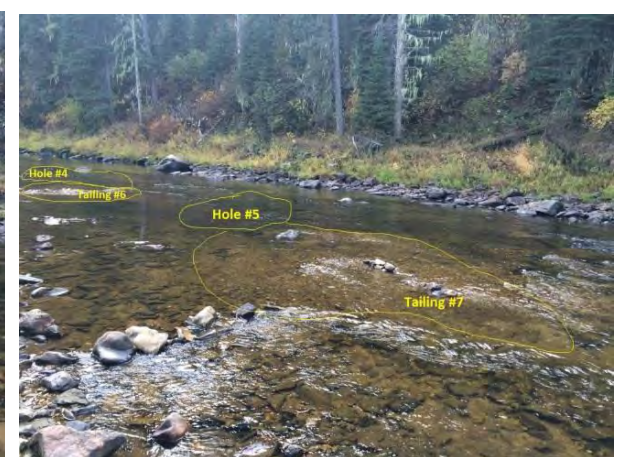
SFCR Unauthorized Site #14, October 8, 2015

Upper feature location	Hughes Site?	Dredge Fines?	WPM?	Notes:
UTM 11 609175E, 5075244N	2	No	No	Some dredge holes/tailings intersperse/indistinct
